NATIONAL ADVISORY COMMITTEE FOR AERONAUTICS

No. 1261

EFFECT OF VARIABLES IN WELDING TECHNIQUE ON THE STRENGTH OF
DIRECT-CURRENT METAL-ARC-WELDED JOINTS IN AIRCRAFT STEEL

JOINTS IN SAE 4130 STEEL SHEET

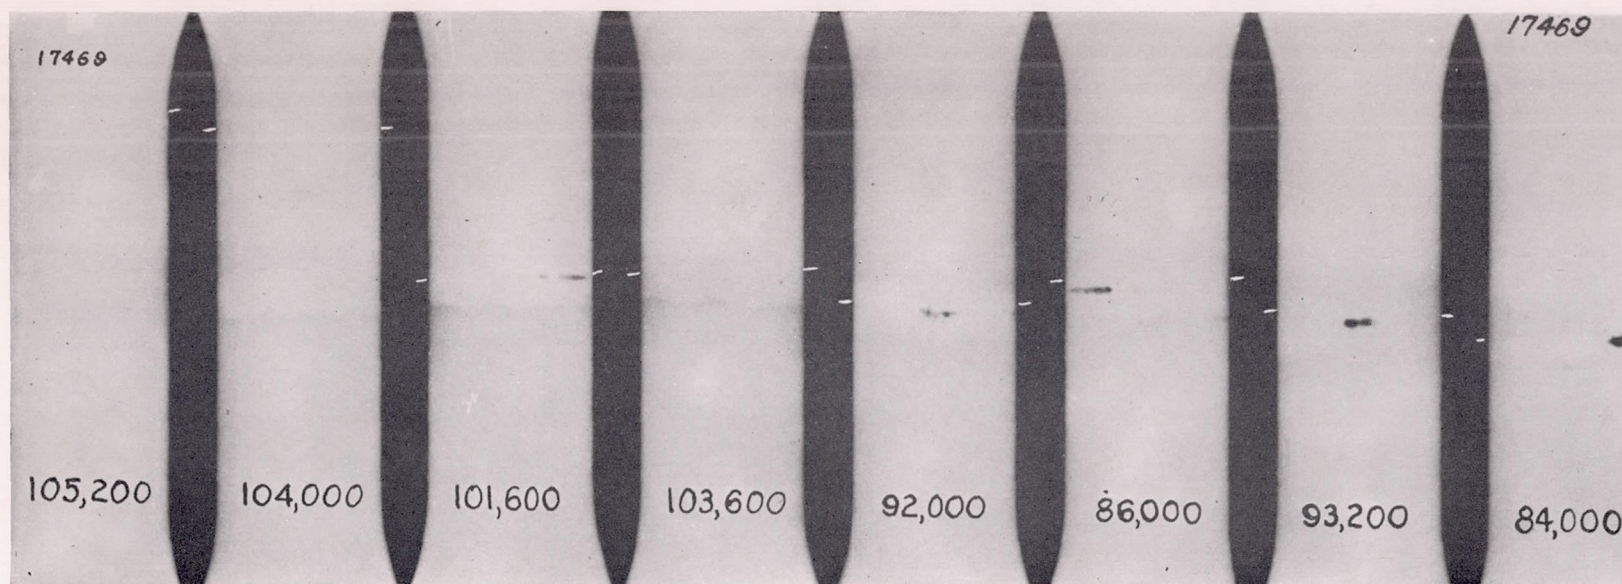
Figure 2.—Radiograph of metal-arc-welded static tension specimens in $\frac{1}{8}$ -inch SAE 4130 sheet.

Transverse lines indicate location of fracture.

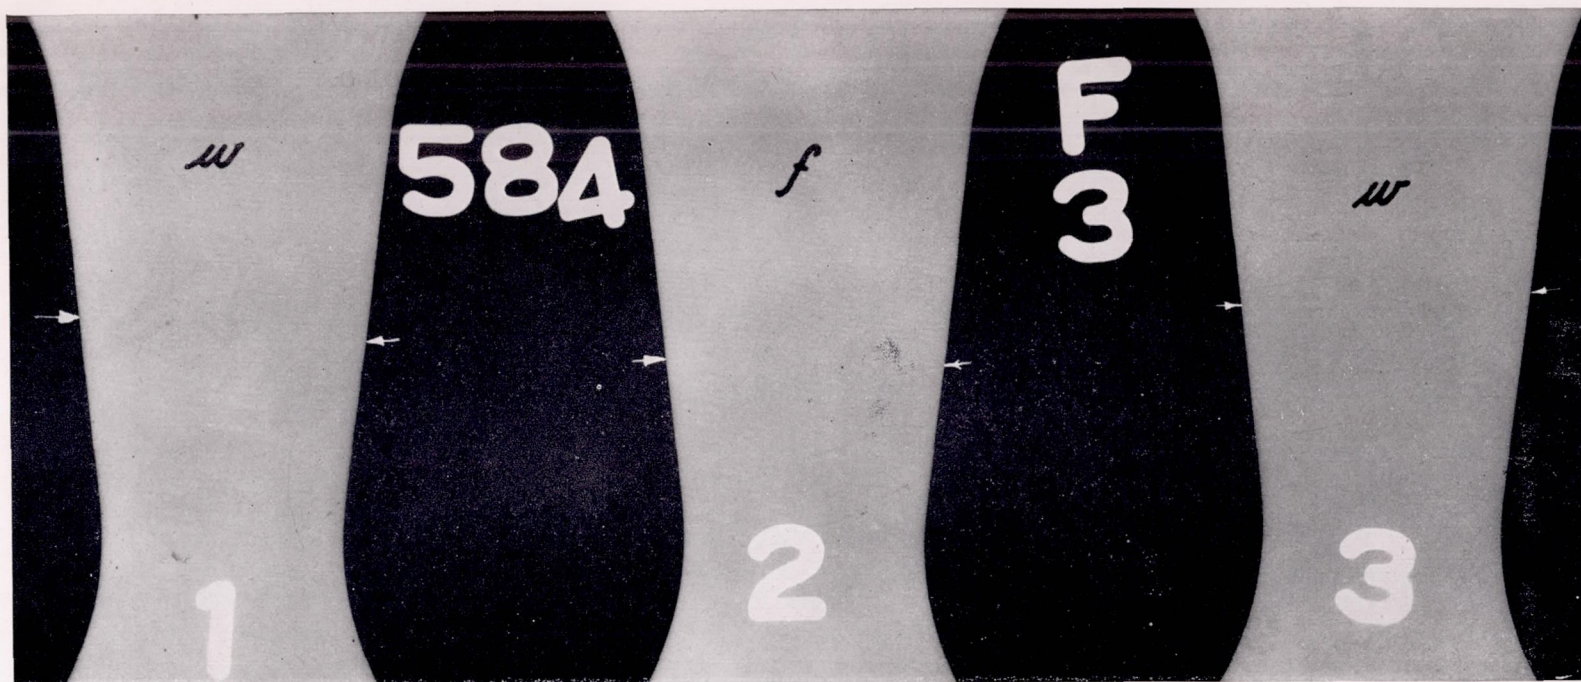
Figure 21.—Radiograph of two-bead, continuous, reinforced welds in $\frac{1}{8}$ -inch SAE 4130 steel sheet (Group 1).

Continuous two-bead weld specimens with full reinforcement (group 1) had a much lower fatigue strength than similar surface-ground specimens (group 2). In all cases the specimens in group 2 failed at the toe of the larger (face) bead and thus indicated the pronounced effect of the stress concentration at that point. (See radiographs, figs. 21(a) and 21(b).)

All fatigue failures at toe of face bead;
no internal defects.

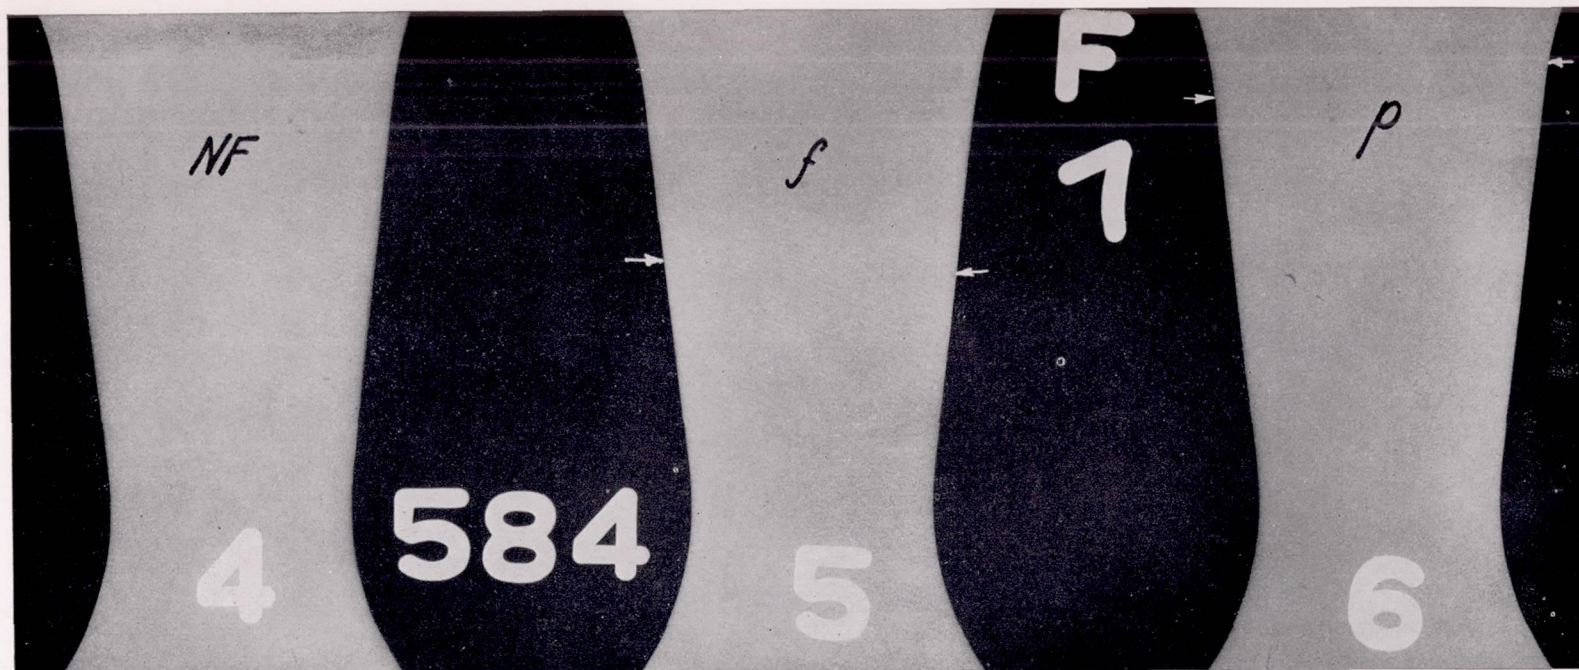
Figure 22a.—Radiograph of two-bead, continuous, flush welds in $\frac{1}{8}$ -inch SAE 4130 steel sheet (Group 2).

fatigue strength of group 2 was probably influenced by the lower strength of the weld metal (two specimens failed on the weld and two in the fusion line), although no internal weld effects were discernible in the radiographs (figs. 22(a) and 22(b)).

Failure in weld;
no internal defects.

Failure in fusion zone;
no internal defects.

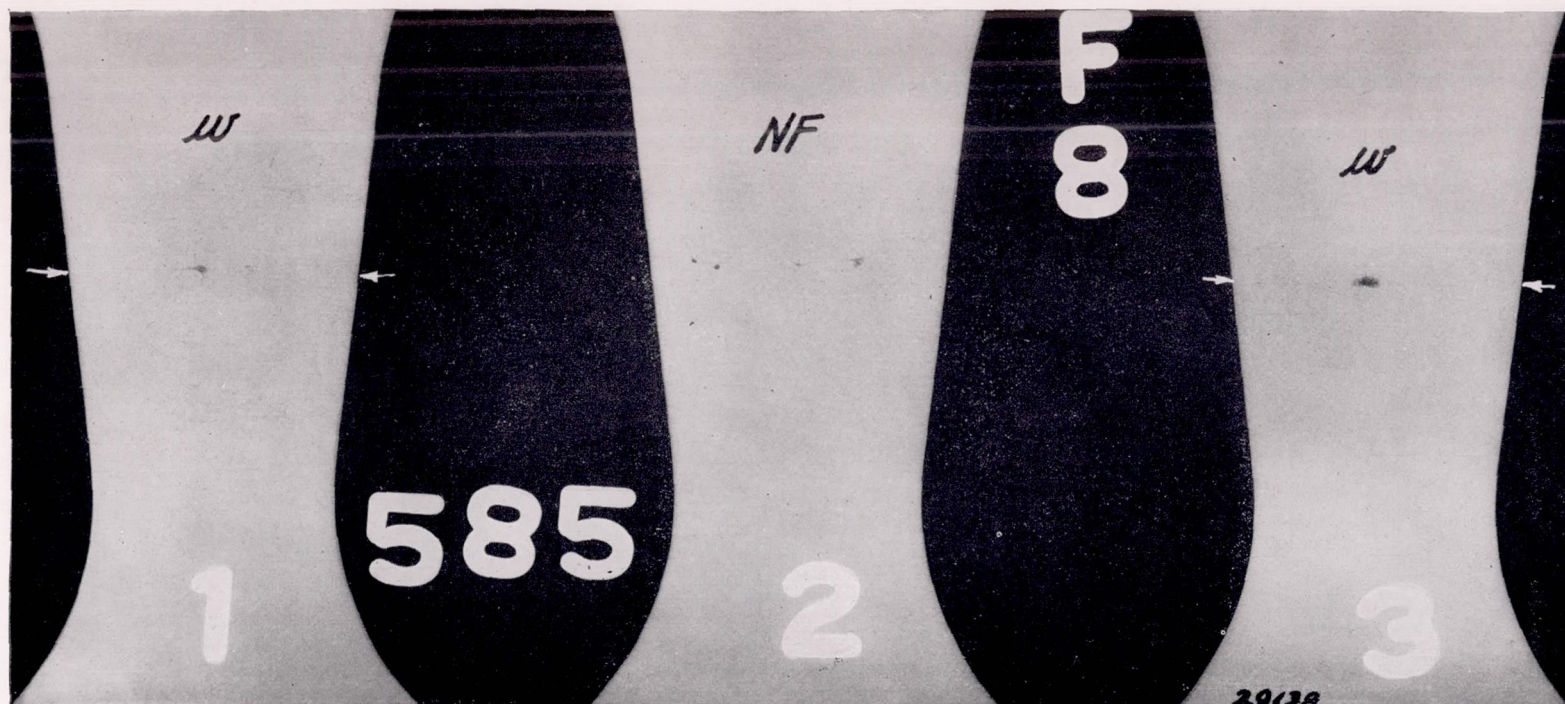
Figure 23b.—Radiograph of two-bead, interrupted, reinforced welds in $\frac{1}{8}$ -inch SAE 4130 steel sheet (Group 3).

The interrupted-weld specimens with full reinforcement (group 3) also failed at the toe of the face bead. (See radiographs, figs. 23(a) and 23(b).) Probably there were internal defects at the point of interruption of the weld, but they are not visible in the radiographs and, if present, had no chance to influence the fatigue strength because of the greater influence of the external stress-raiser at the toe of the face bead. Figure 29 shows that the toe-of-weld stress-concentration effect was greater for the interrupted-weld specimens (group 3) than for the continuous-weld specimens (group 1). This is possible because the face bead in the group 3 specimens was higher and fuller with incipient overlapping at the weld interruption.

All failures at toe of face bead;
minor sidewall blowholes or slag
inclusive; no crater defects visible.

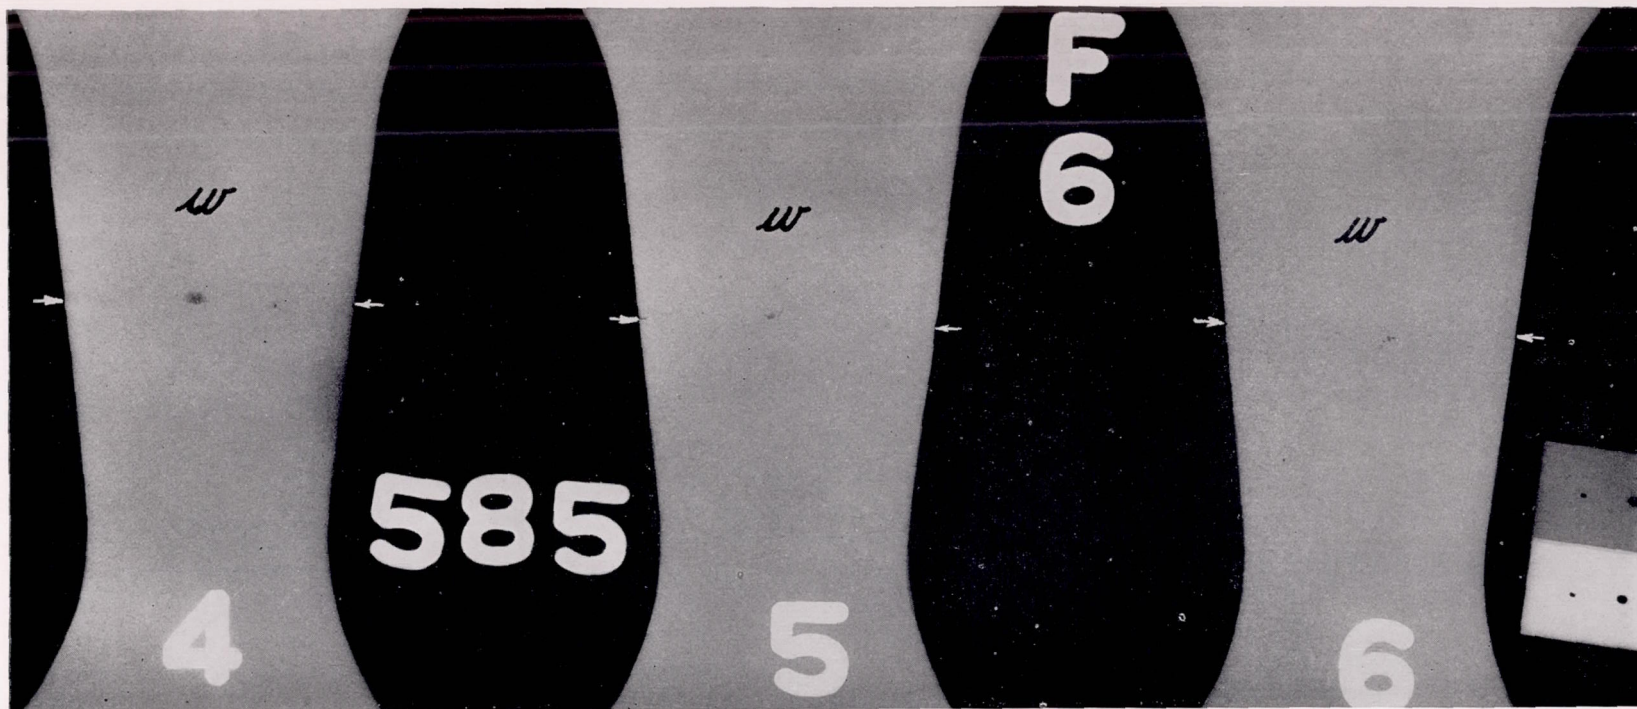
Figure 24a.—Radiograph of two-bead, interrupted, flush welds in $\frac{1}{8}$ -inch SAE 4130 steel sheet (Group 4).

The surface-ground, interrupted, two-bead welds (group 4) had a higher fatigue strength than the companion specimens with full reinforcement (group 3). The radiographs in figures 24(a) and 24(b) indicate that the location of fatigue failure of the group 4 specimens was influenced by the presence of crater defects at the weld interruption, although the fatigue strength of weld metal itself may have had an effect.

Failure in center of weld;
crater blowhole with
transverse crack.

No fatigue failure;
one sidewall pit;
small crater crack
(three black spots at left)
are film defects).

Failure in center of weld;
crater blowhole.

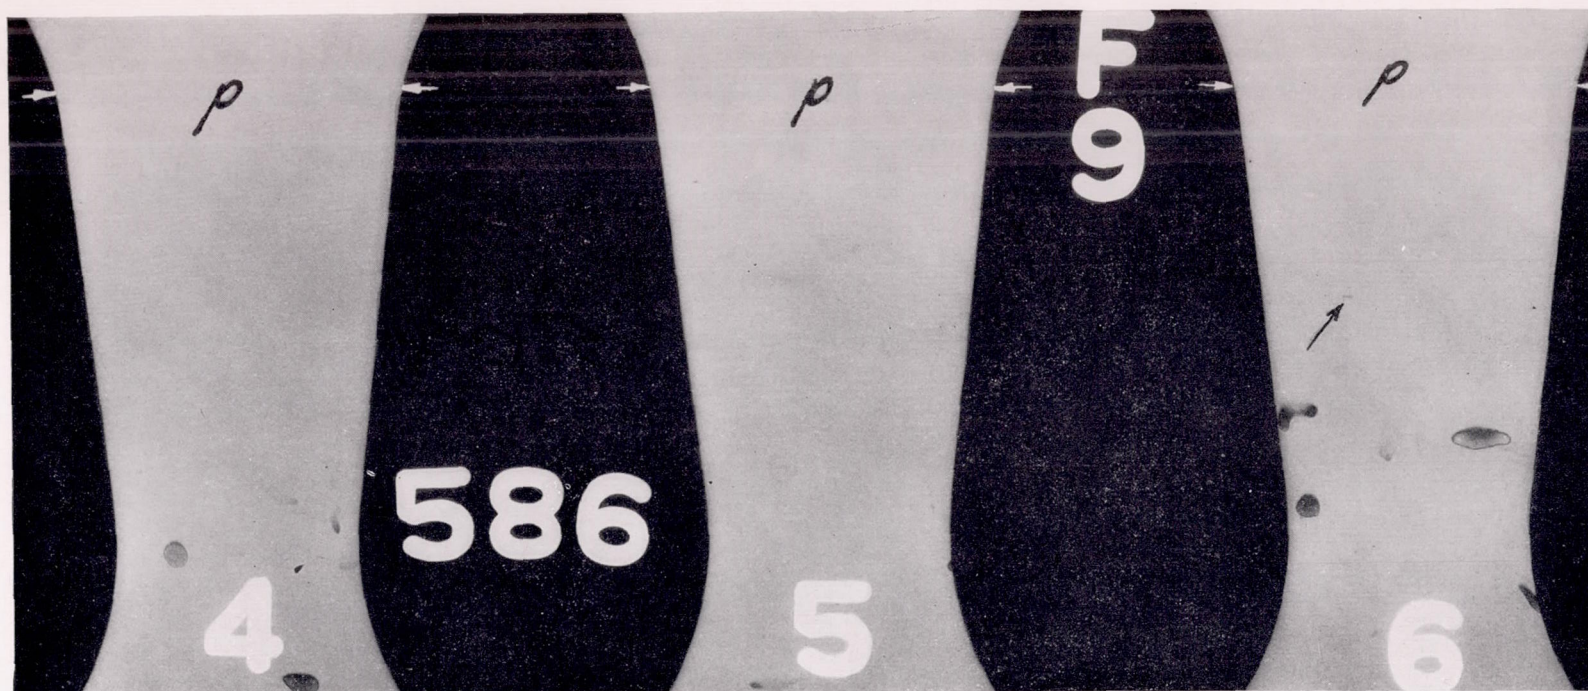
Figure 25.—Radiograph of single-bead, continuous, reinforced welds in $\frac{1}{8}$ -inch SAE 4130 steel sheet (Group 5).

All failures at toe of weld bead;
no root defects or lack of penetration visible.

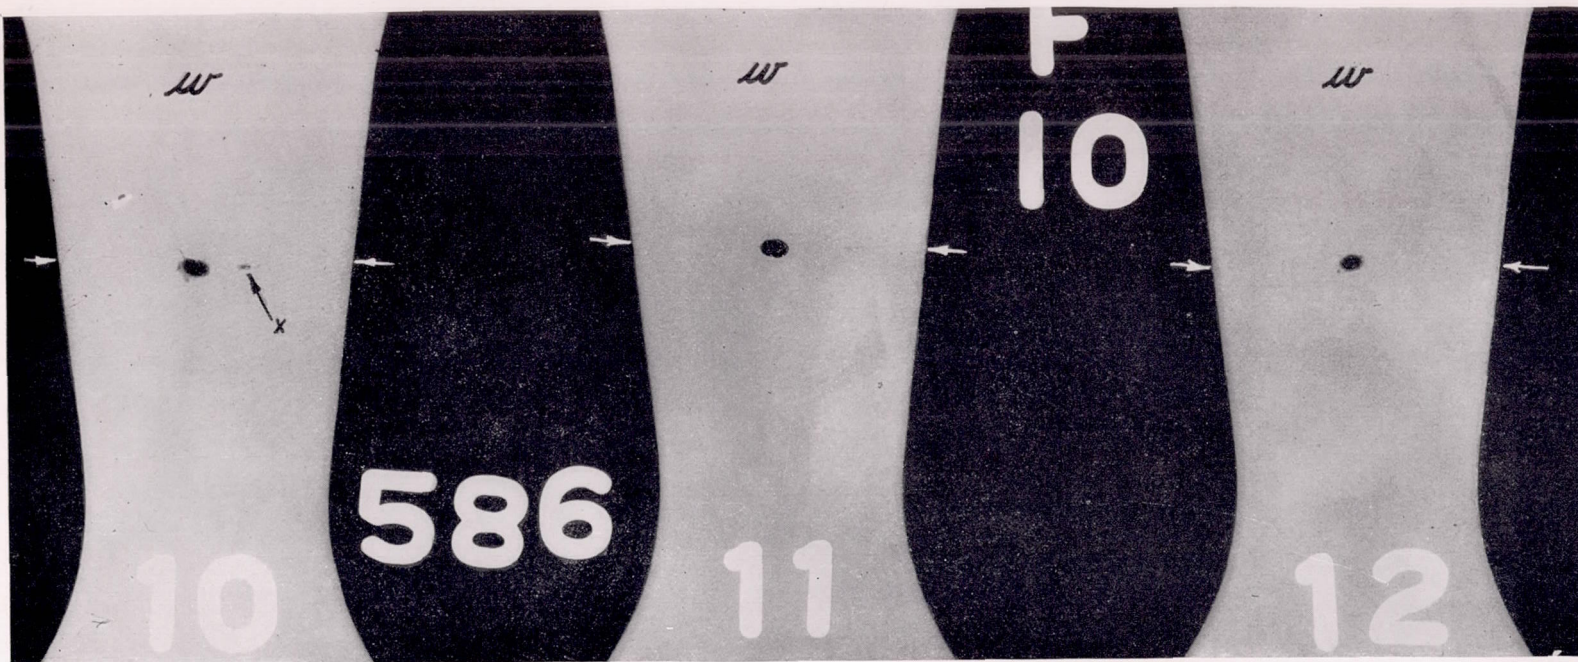
Figure 27.—Radiograph of single-bead, interrupted, reinforced welds in $\frac{1}{8}$ -inch SAE 4130 steel sheet (Group 7).

Failure at toe of weld;
elongated crater blowhole and
longitudinal crater crack.

Failure at toe of weld;
small crater hole and transverse
crater crack.

Failure at toe of weld;
crater blowhole.

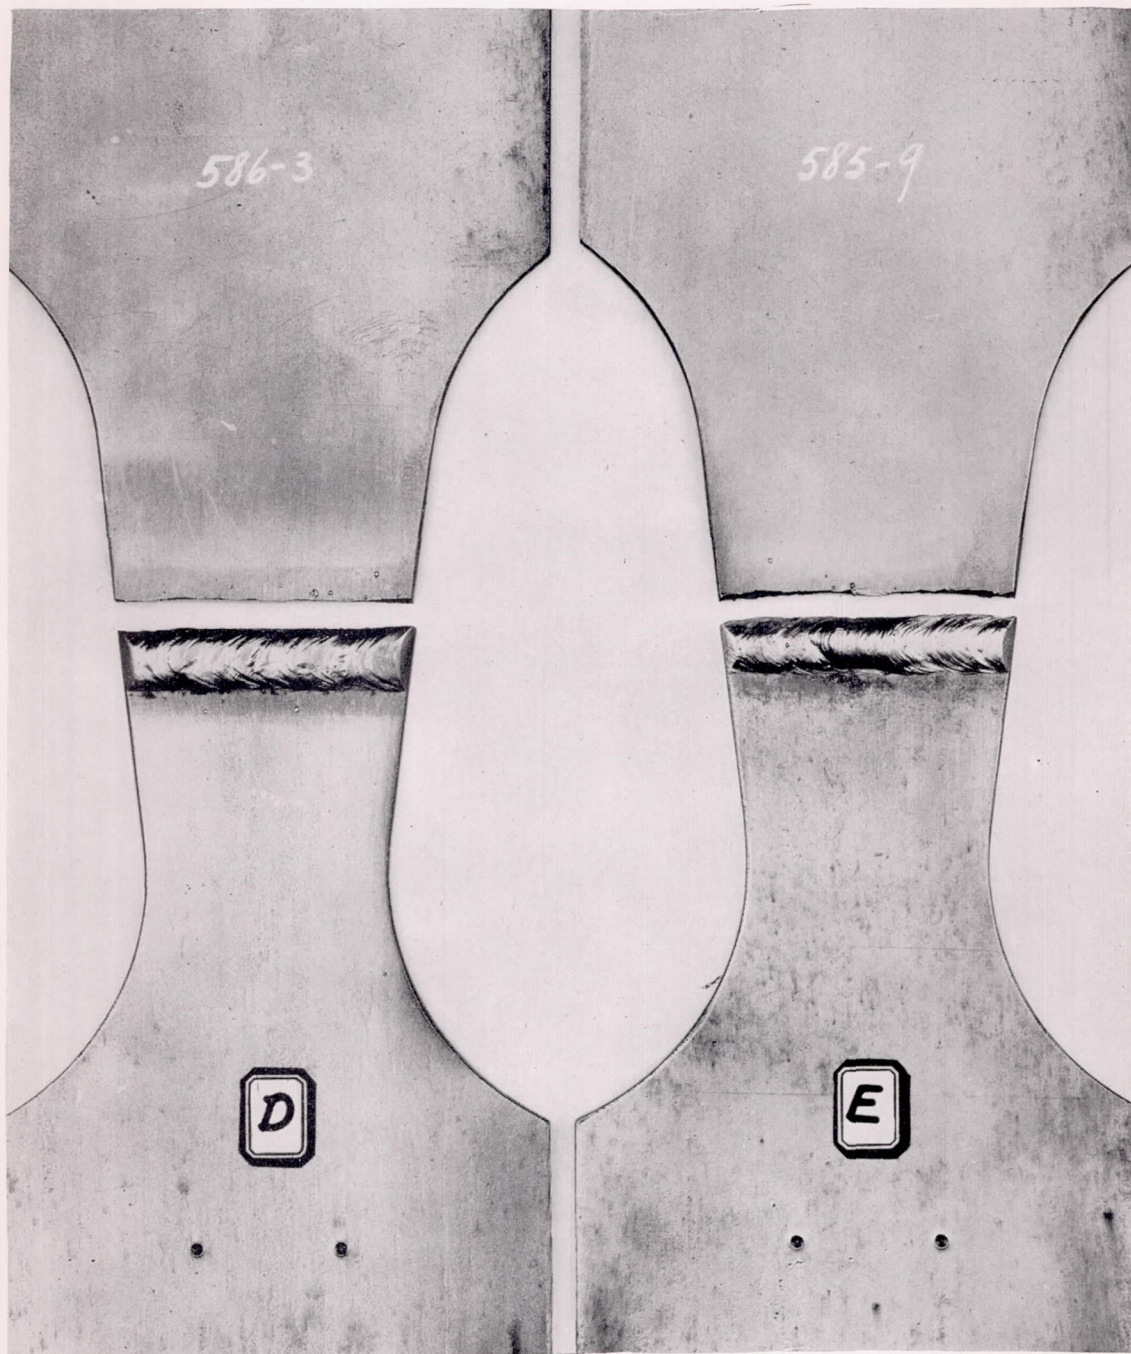
Continuous single-bead weld
(face side).

Interrupted two-bead weld
(face side).

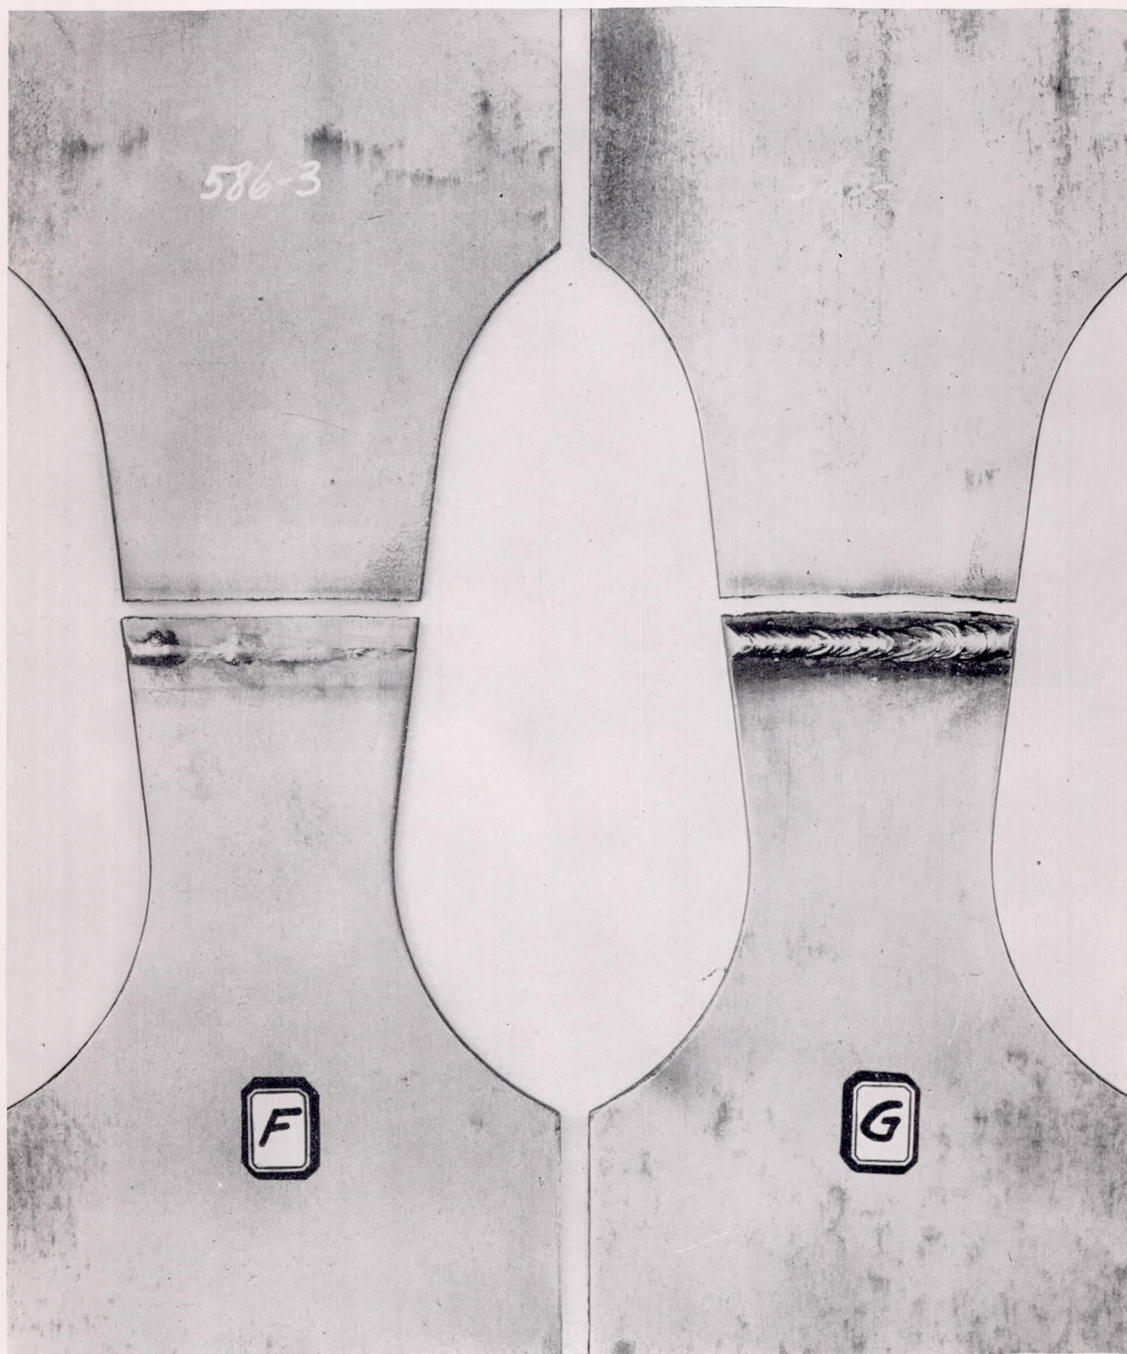
Figure 31.—Typical plate-bending fatigue fractures at toe of weld bead (face-weld views).

Continuous single-bead weld
(root side).
Failure at toe of face bead.

Interrupted two-bead weld
(root side).
Failure at toe of face bead.

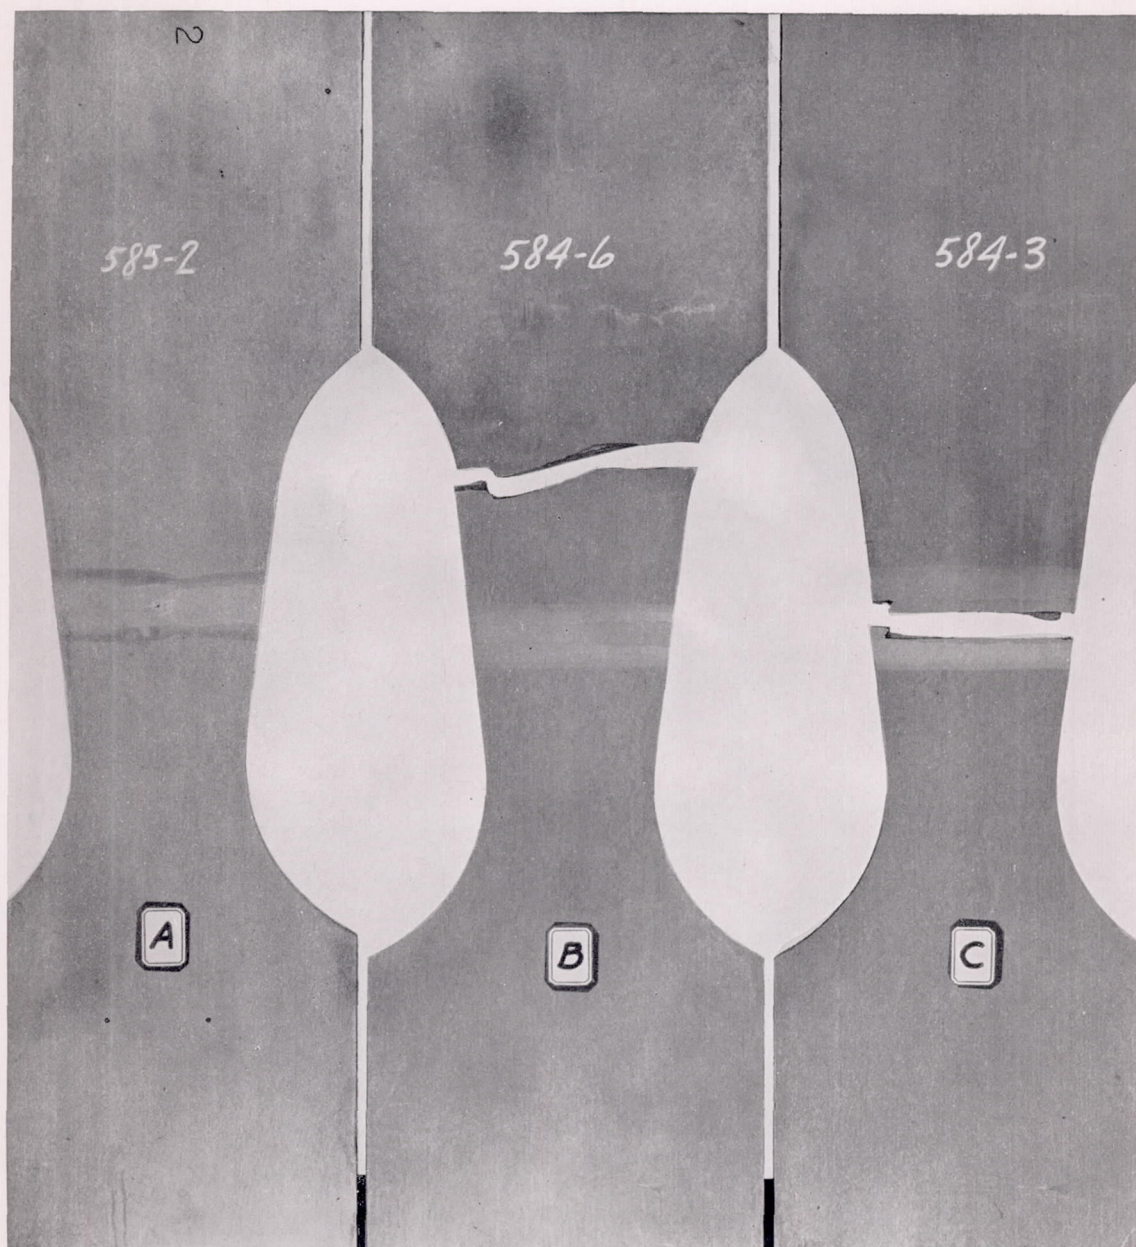
FIGURE 33.—Typical plate-bending fatigue fractures in welded specimens with no reinforcement

- A—Interrupted two-bead weld (no failure).
B—Continuous two-bead weld (failure in plate at change of section).
C—Continuous two-bead weld (failure in center of weld).
